# Manhole Inspection Summary

Manhole # S25II2004MH

Insp Date: **3/27/07 10:39 AM**

**Location** Address: **5900 LAKE AVE** Cross Street: **LAKEHURST DR**

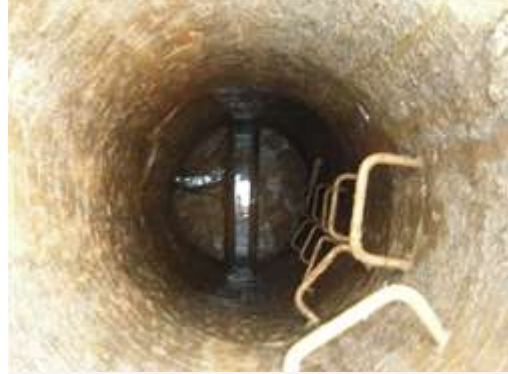
Top View

**Bench** ☒ Exists Material: **Brick** ☐ Parged ☒ **Debris** (not Condition related)  
Condition: ☒ Sound ☐ Cracked ☐ Root Intrusion ☐ Deteriorated ☐ Leaks ☐ Debris

**Steps** Count: **10** Missing: **0** ☒ **Corroded**

Corroded steps. Bench debris.

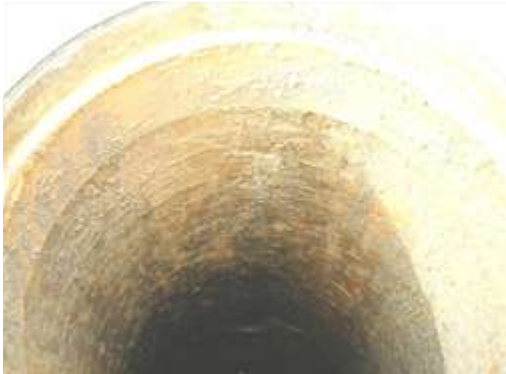
Defect

**Frame** Offset: **0** (in.) Condition: ☐ Sound ☐ Cracked ☒ **Leaks**

**Chimney / Frame Adjustment** ☒ Exists Material: **Brick** ☐ Parged Height: **3** (in.)  
Condition: ☒ Sound ☐ Cracked ☐ Root Intrusion ☐ Loose Brick ☐ Deteriorated  
Infiltration: ☐ None ☒ **Joint** ☐ Cracks ☒ **Mortar** ☐ Roots ☒ **Wall**

**Corbel** Material: **Brick** ☐ Parged Type: **Concentric/Eccentric**  
Condition: ☒ Sound ☐ Cracked ☐ Root Intrusion ☐ Loose Brick ☐ Deteriorated  
Infiltration: ☐ None ☐ Joint ☐ Cracks ☐ Mortar ☐ Roots ☒ **Wall**

Frame leaks. Adjustment, Corbel and Barrel infiltration.

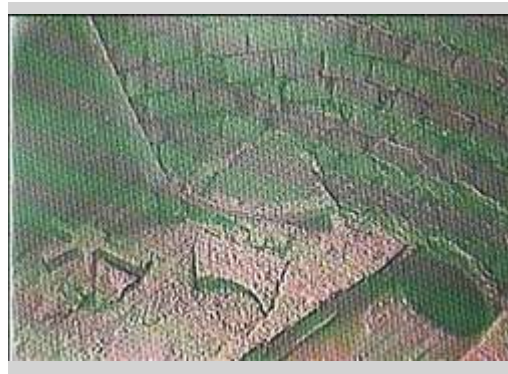
Defect

**Barrel** Material: **Brick** ☐ Parged  
Shape: **Circular** Diameter: **42** (in.) Length: (in.)  
Condition: ☐ Sound ☐ Cracked ☐ Root Intrusion ☐ Loose Brick ☒ **Deteriorated**  
Infiltration: ☐ None ☐ Joint ☐ Cracks ☒ **Mortar** ☐ Roots ☒ **Wall**

Barrel deterioration and infiltration.

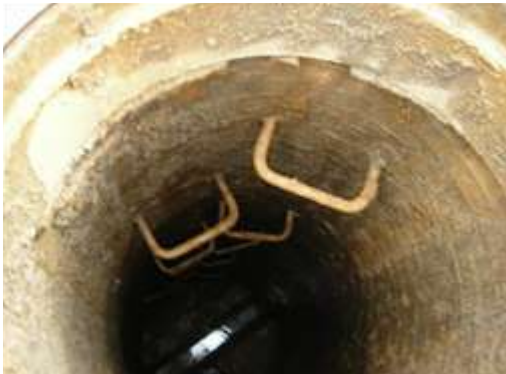
Defect

Frame leaks. Adjustment, Corbel and Barrel infiltration - other side.

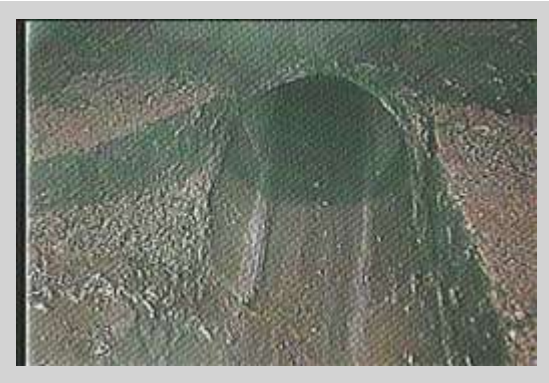
### 10 in. Circular Gravity Sewer Pipe Out @ 12 O'Clock

Deposits: ☐ None ☐ Mud ☐ Sludge ☐ Debris ☒ Grease

Infiltration: **Evidence** Pipe Seal Cond: **Cracked**

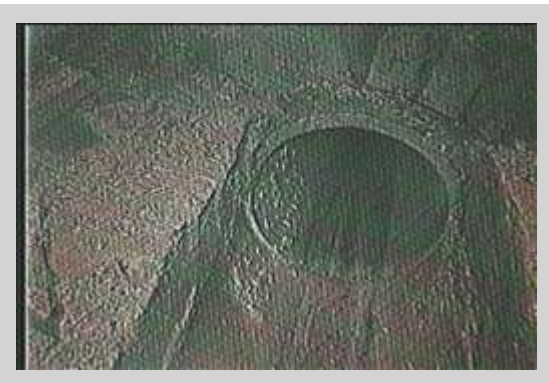
### 10 in. Circular Gravity Sewer Pipe In @ 6 O'Clock

Infiltration: **Evidence** Pipe Seal Cond: **Cracked**

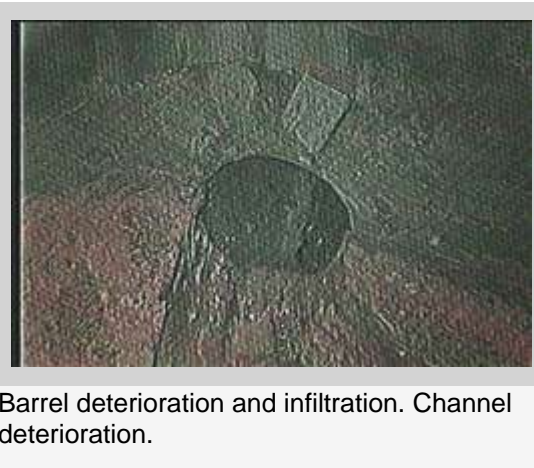
Drop In @ 9 O'Clock

Comments **The Drop ext. I9 pipe picture shows Channel deterioration.**

**Channel** Material: **Brick** ☐ Parged ☐ Debris (not Condition related)  
Channel Exposure: **Fully Open** Junc Dist: **0.5** nearest .5 ft. Azimuth: **260**  
Condition: ☐ Sound ☐ Cracked ☐ Root Intrusion ☒ **Deteriorated** ☐ Leaks ☐ Debris

Barrel deterioration and infiltration. Channel deterioration.
